# T-REX PROJECT INTERNATIONAL RUBBER NEWS

## Project Mobile Crusher, Norway

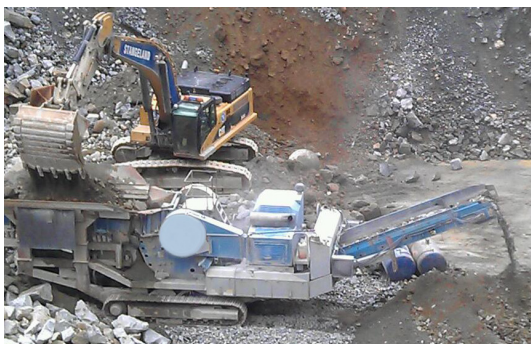
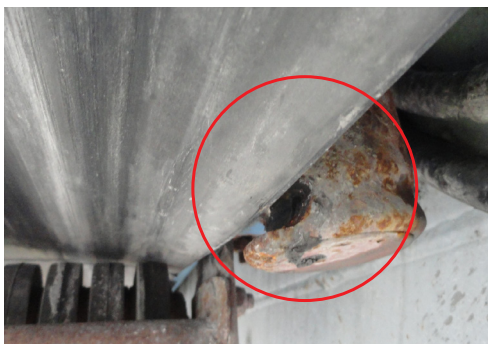
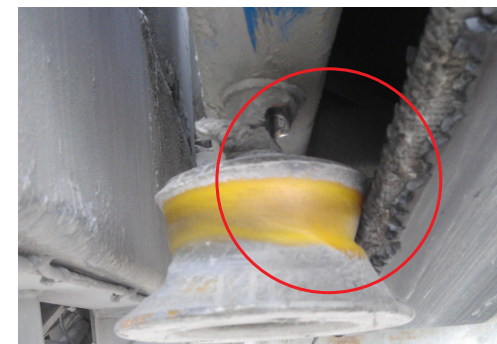
Damage caused by misalignment conveyor belt  
Conveyor Belt: Ripstop, width 1400 mm

We provided solution by installing a Tru-Trac® Flat Return Tracker  
Challenge : limited space for installation  
No space for belt to misalign
